# Restore Hope Latimer (Little Chess) - Comparison report

## Part A – Modular River Survey

Smarter Water Catchment Programme

July 2024

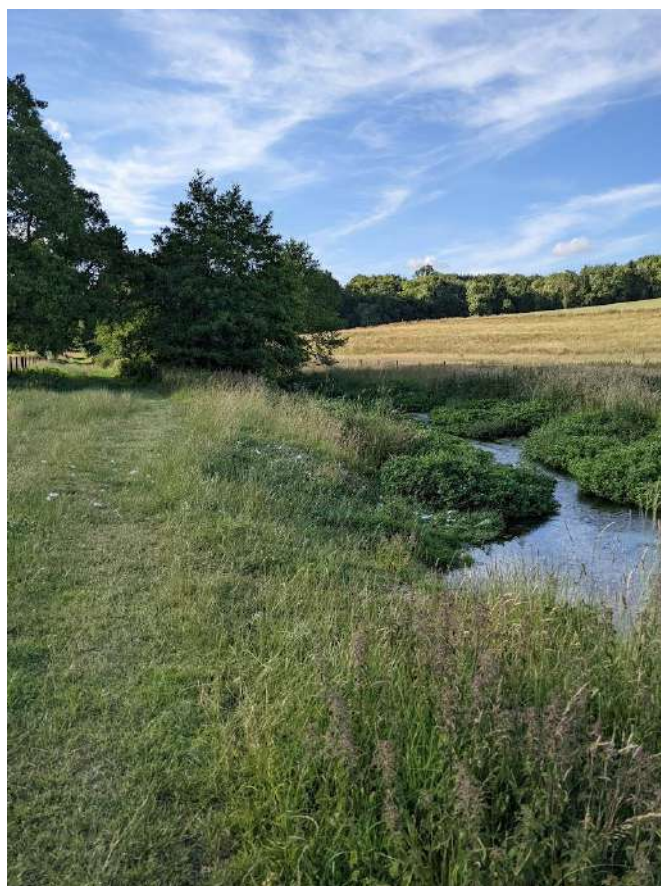
**Figure 1.1** General view of the Little Chess at Restore Hope Latimer (Little Chess) during the baseline surveys, taken from Subreach 7.

The initial surveys were undertaken on 9 subreaches<sup>3</sup> of the Little Chess (Figure 2.1) at Restore Hope Latimer (Little Chess) in July and October 2022. The River Chess has been affected by centuries of historical modification, including canalisation and drainage for flood defence, farming and fishing pursuits, urban development and for industries such as milling. In the late 18<sup>th</sup> century, the River Chess was separated into two channels, creating the Little Chess and the main River Chess. The Little Chess channel is artificial and as a result is straighter and wider than it would naturally be. The land use at the site is predominantly agriculture, and the floodplain is used for sheep and cattle grazing. Extensive grazing by livestock on the floodplain has led to poaching of the channel banks. As a result, there has been increased erosion of the channel banks which has caused fine sediment to enter the river. (Figure 1.1).

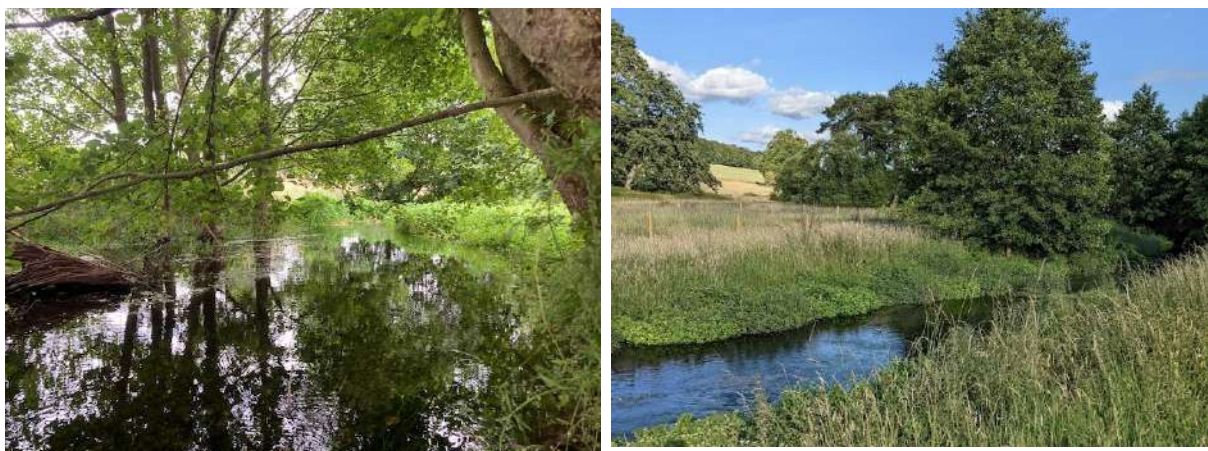
**Figure 2.2:** Photos of flow types during the baseline surveys taken at Subreach 4 (left) and Subreach 7 (right).

The baseline MoRPh data (Figure 2.5 and Figure 2.6) show the average number of flow types (Index 1) were relatively low (1.5-2.5), about the same as the UK chalk stream average, but well below what the river would naturally contain (pre-modification) (Figure 2.2). The highest energy flow types recorded were mainly rippled and unbroken standing wave.

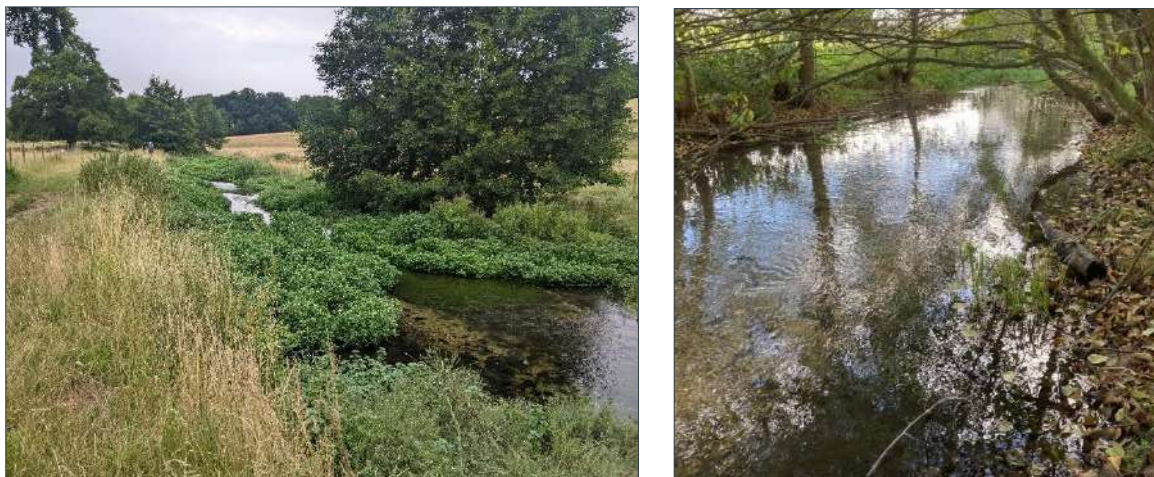
**Figure 2.3:** Evidence of the variability of the riparian vegetation and number of aquatic vegetation morphotypes. Limited riparian cover and higher amount of vegetation morphotypes shown at Subreach 8 (left) and less aquatic vegetation morphotypes shown at Subreach 2 (right).

Average channel physical habitat complexity (Index 8) and the number of aquatic vegetation morphotypes<sup>5</sup> (Index 9) were both slightly above the UK chalk streams average. The numbers of aquatic vegetation morphotypes<sup>5</sup> varied along the channel within the site. This is likely reflecting the variability of channel shading by the riparian vegetation which fluctuates between overgrown and limited along the channel (Figure 2.3).

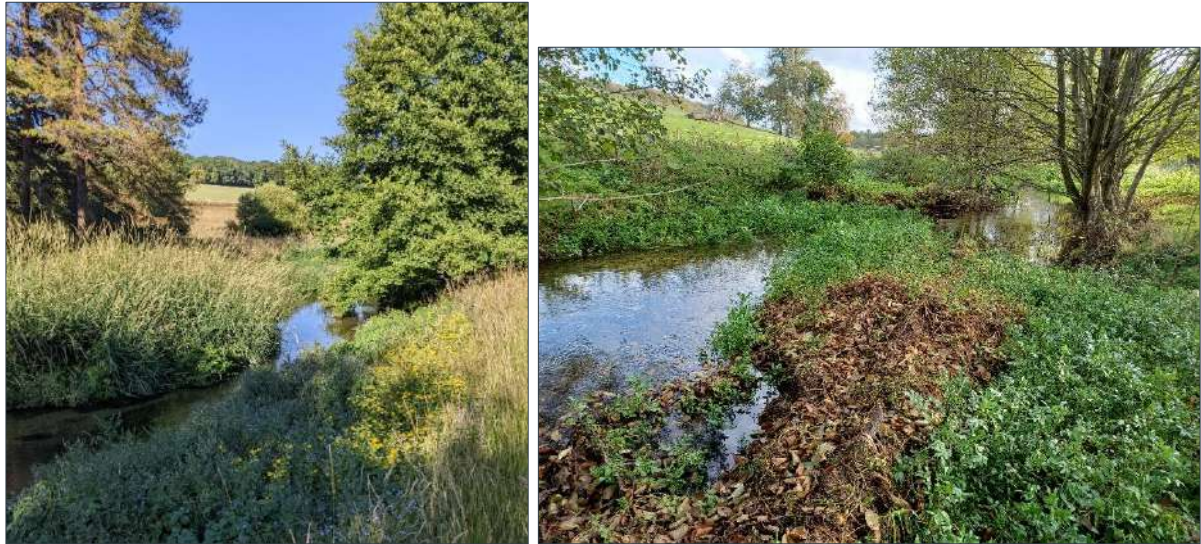
**Figure 2.4:** Photos of the riparian cover during the baseline surveys. Taken at Subreach 9 (left) and Subreach 3 (right).

The average baseline riparian vegetation structural complexity (Index 11) was relatively good, but the average riparian physical habitat complexity (Index 10) was about average compared to other UK chalk streams (Figure 2.4 and Figure 2.5).

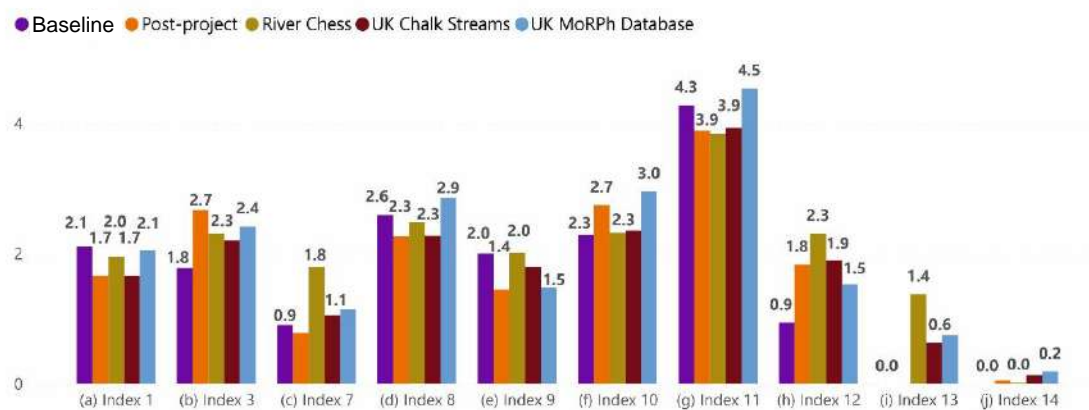
**Figure 2.5** Summary of the baseline (purple) and post-project (orange) averages of the MoRPh indexes<sup>6</sup>. Also shown are index value comparisons for all MoRPh surveys on the Restore Hope Latimer Little Chess (brown), UK average chalk stream values (Red), and average values for all rivers within the Citizen Science MoRPh database (blue).

Post-project' MoRPh surveys were undertaken in 2023 (16 months following restoration) and comparisons of the MoRPh indexes are summarised in Figure 2.5. A breakdown of the different indices is also shown in Figure 2.6.

The results show improvements in the average diversity of bed material (Index 3), which is now higher than the UK chalk stream average. The average extent of superficial bed siltation (Index 7) has shown a slight increase. Whilst this may seem negative, this likely reflects an increase in sediment trapped in newly created backwater areas between flow structures and is part of the river naturally adjusting to the new hydraulic conditions.

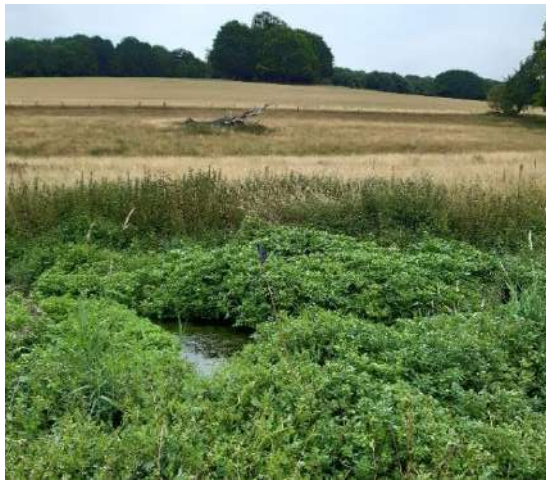
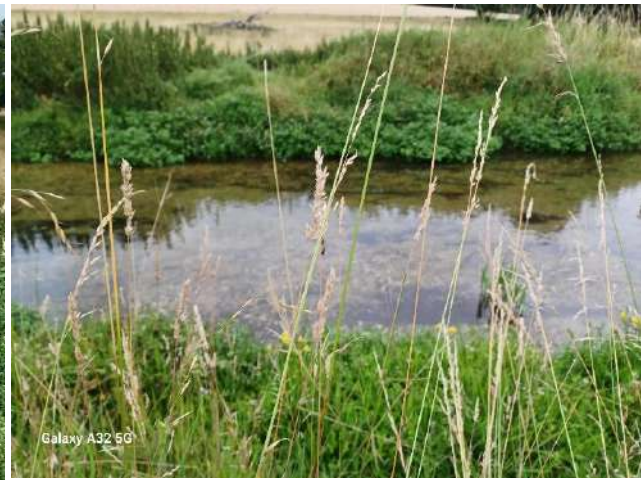
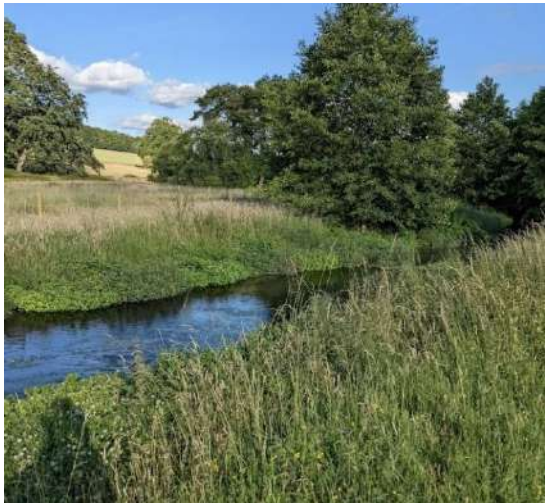
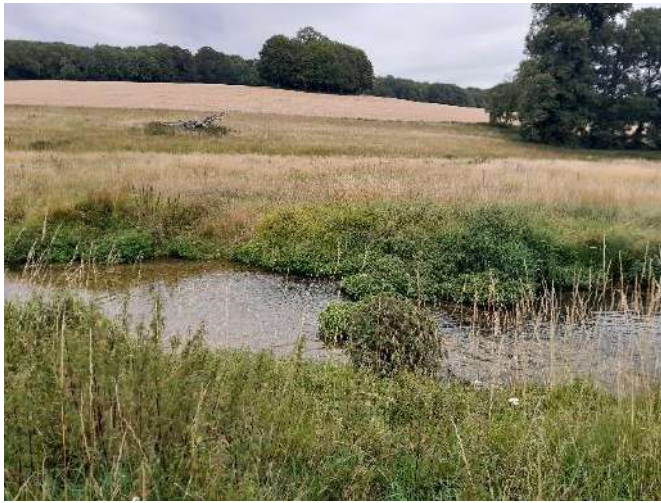
**Figure 4.1:** Left photos show baseline conditions and right photos show post-recovery conditions demonstrating the changes in bed material.

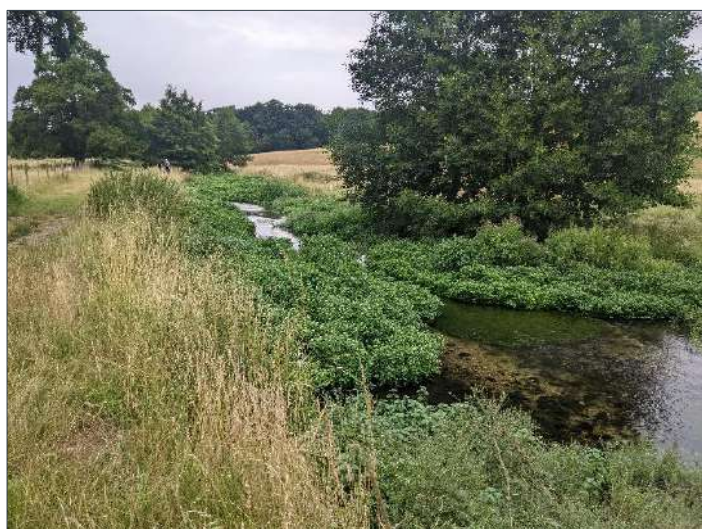
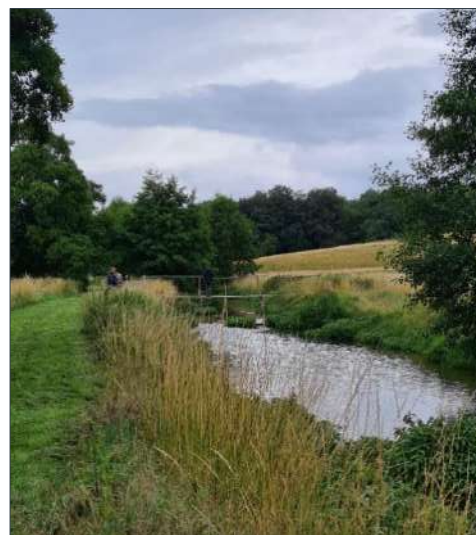
A detailed breakdown of changes to riparian physical habitat complexity (Index 10) is shown in Figure 4.4. Increases in the riparian habitat complexity (Index 10) are most distinct at subreaches five, six, seven, eight (Figure 4.3), and nine. This is potentially a reflection of the new fencing that the bank conditions are starting to recover from the impact of livestock grazing and poaching. However, similar to the improvements recorded in bed material type, many factors can influence the results including access to the channel bank which can vary between each survey due to vegetation growth.

Figure 4.3: Photos of the riparian conditions during the baseline (left) and post-recovery (right) surveys.

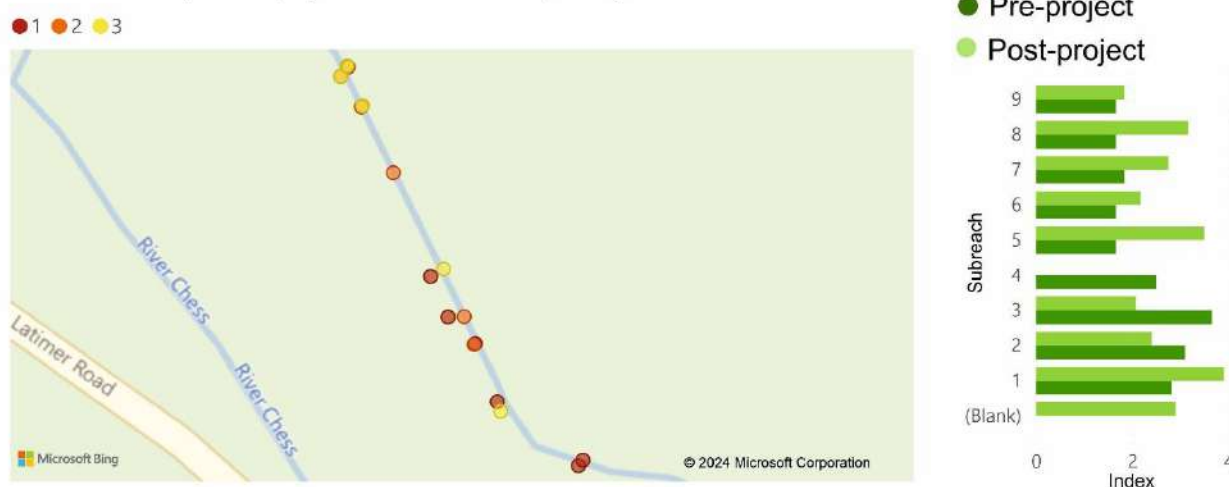
There have also been modest improvements to the average riparian habitat complexity (Index 10), which is now slightly above the UK chalk stream average.

Figure 4.4: Index 10 at each subreach.
